St Margaret, Crick, Northamptonshire

1819 organ by Thomas Elliot
2008-9 restoration by Martin Goetze and Dominic Gwynn

Progress Report 1, November 2008

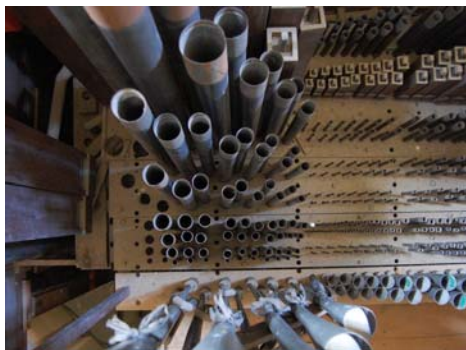
Great pipes before dismantling. Note empty holes for bottom notes and the Oboe type reed pipes.

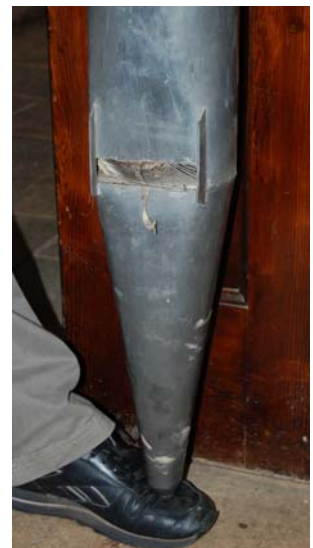
A bird in a pipe mouth

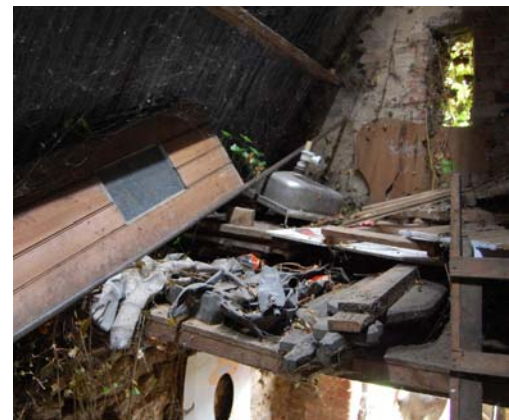
Metal pipes in the sexton's hut

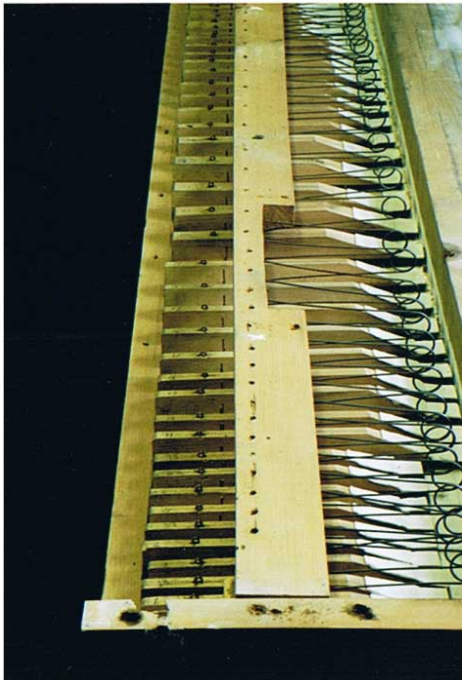
Swell soundboard has been fitted with a new brass strip as the original had been drilled oversize and had poor registration to the pallet centres. Some new timber was jointed onto the bottom board, the original having serious knots in the face edge, and worm. A table split was repaired. Some pallet spring holes were repositioned, the originals being somewhat erratic.

Swell pallets before restoration, showing poor alignment of both pallets and pull-down eyes

Pallets were covered in a double layer of sheepskin, springs cleaned and reset. Some modification to the spring rails were made with new threaded brass fixings for the Choir. New phosphor bronze pull-downs were fitted with red cloth bushing.

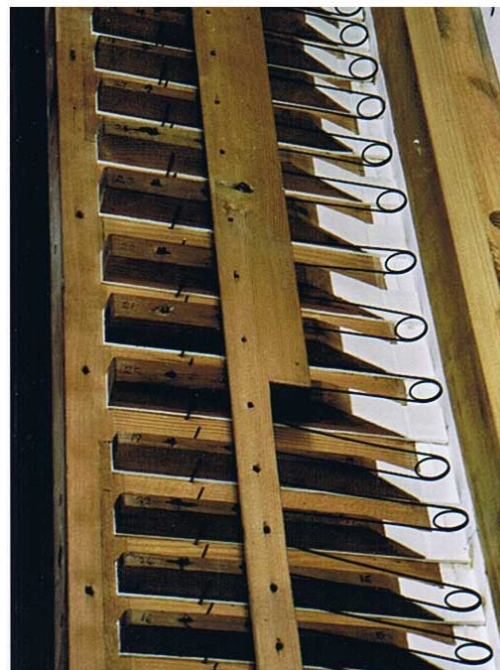
Pallets after restoration

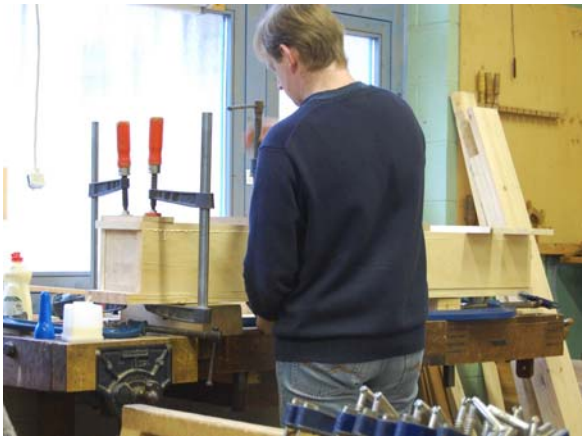
James gluing a new Stopt Diapason GG pipe

The wood pipes were examined, sorted and measured. They were cleaned and checked for defects. Many caps had become slightly detached, and there were one or two splits. In both cases, the area of the pipe was steamed with a damp rag and iron; very hot water was brushed as far into the cracks as possible; glue was brushed into the opening before applying pressure with cramps, subsequently warming the joint with a heated air gun. Surplus glue was wiped off. Stoppers were taken out, cleaned with a stiff brush held over a vacuum cleaner, and then blown off with compressed air. Where the sheepskin gasketting had failed, a new piece was prepared and put on. Scale diagrammes were made so that missing pipe measurements could be extrapolated. New pipes were made to match the existing ones.
