St Margaret, Crick, Northamptonshire

1819 organ by Thomas Elliot
2008-9 restoration by Martin Goetze and Dominic Gwynn

Progress Report 2, January 2009

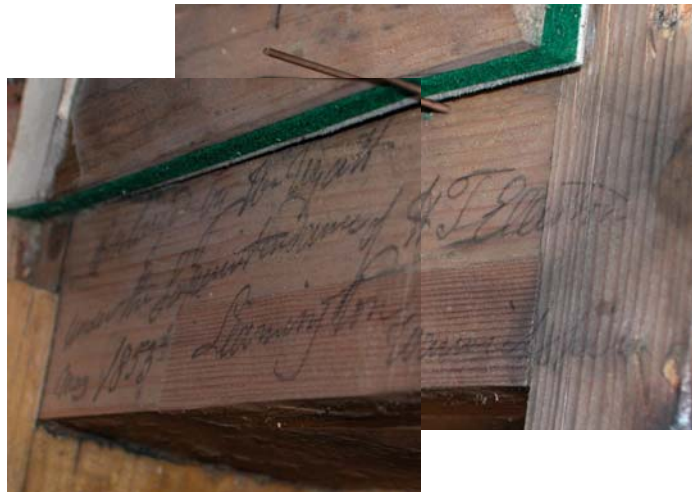
The pedal department is in two parts: a seventeen note soundboard with pipes, and an additional, modern, soundboard with more recent pipes. It had been assumed that the seventeen note part dated from the arrival of the organ at Crick, or even possibly earlier. The pencilled inscription inside reveals that it is from 1853, made under the supervision of H. T. Elliston of Leamington.

The additional soundboard was made in 1978 by Robert Shaftoe, though the pipes appear to be late nineteenth century, from an unknown source. It was decided that these pipes should be retained, but three new ones at the top added in order to complete the pedal compass to f. The 1978 soundboard is made from chipboard, and although is good condition, did not allow for the additional pipes. A new soundboard has been planned, and it will be made following the details of the 1853 soundboard.

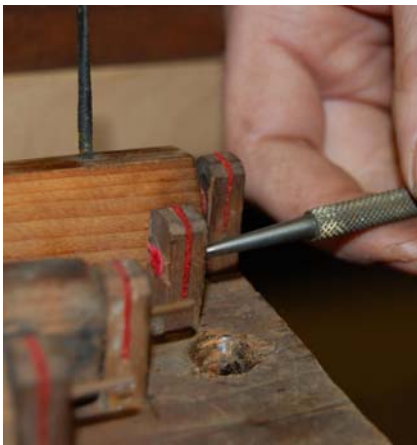
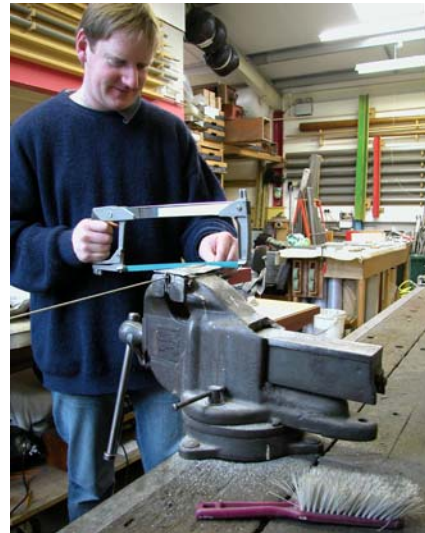
One detail needing attention was the bushing of the roller boards. The original method was to saw a slot in the stud and glue in a piece of cloth. The bearing surface in the cloth is not much more than 1mm thick, and it is not surprising that subsequent work involved re-bushing along the length of the hole, which became the most widespread method. We have retained this, using new cloth.

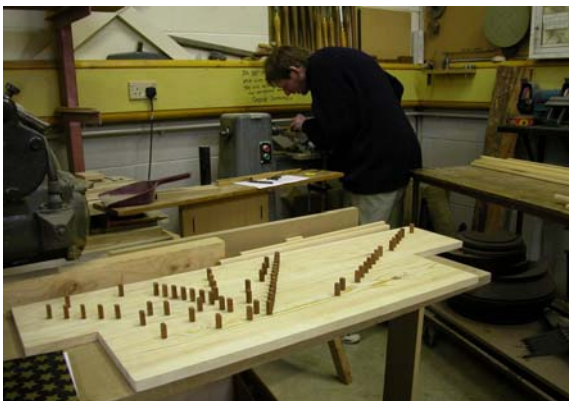
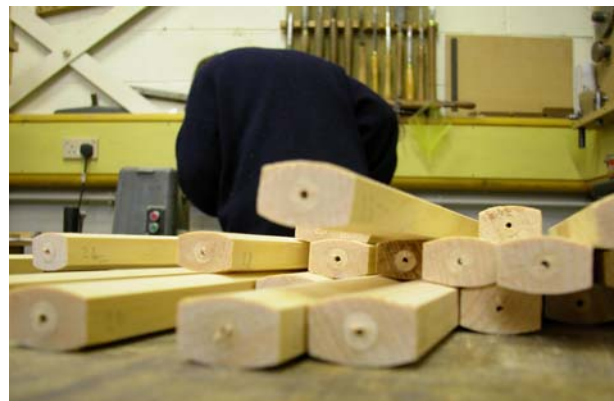
James drilling rollers for the Pedal coupler roller board. The pine rollers have an insert of lime for better wear.

The action to the old pedal soundboard was arranged with a direct connection between the pedalboard and the squares at the back, resulting in an unsatisfactory splayed layout. A reconstruction of the likely original plan has been made, which has involved two new roller boards and a square beam for the additional soundboard.

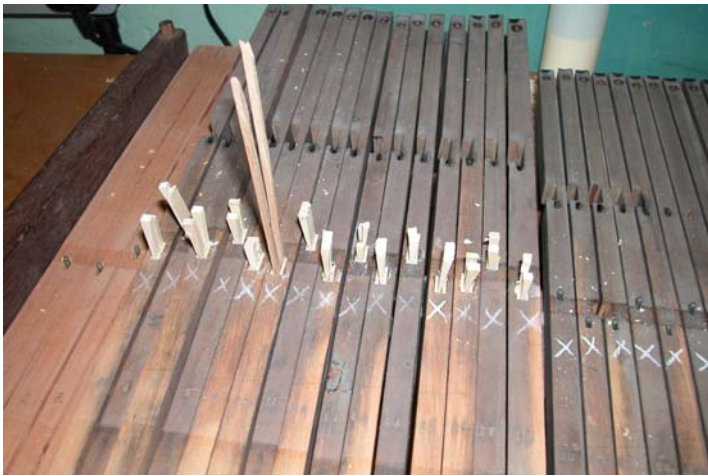
Balance pin slots with new sides glued in

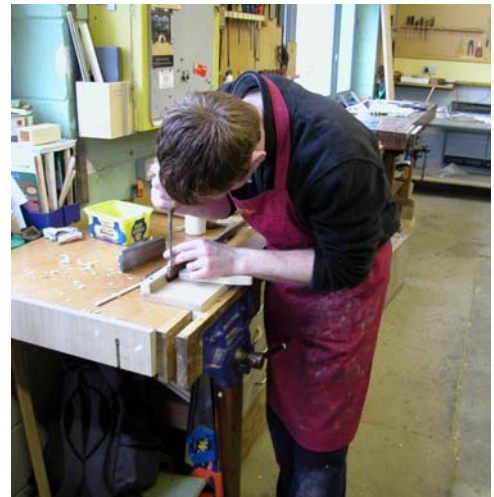
Nick fitting the restored guide pin slot to the keyboard

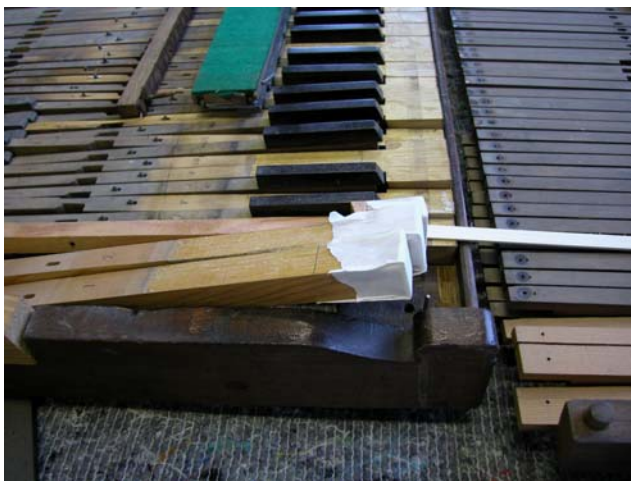
Vertical grained lime glued on the key fronts

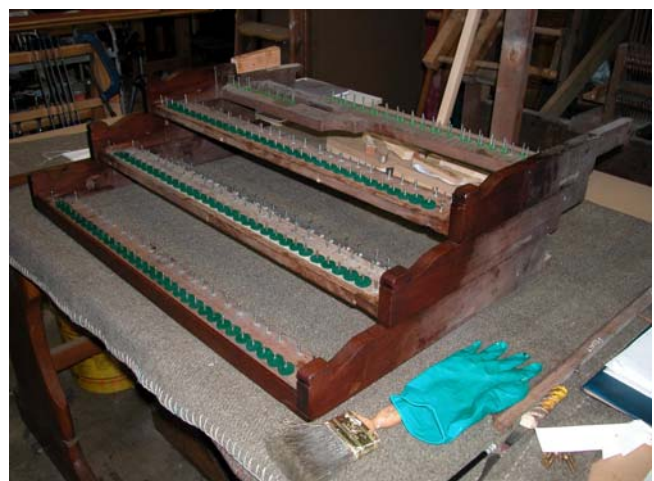
Conservation of the keyboard frame surface

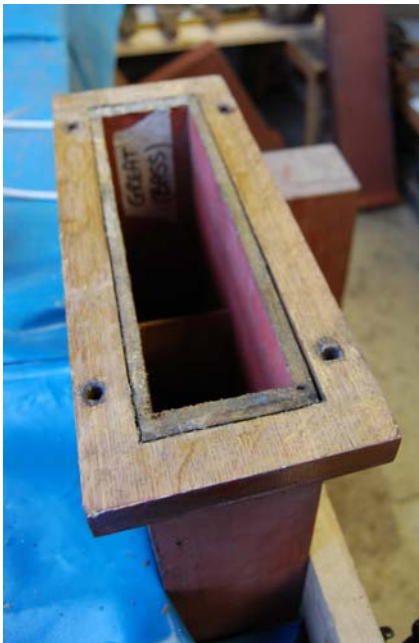
The wind trunks have all been cleaned and repaired, and new sheepskin gasketting glued on. The fixing frames appear to have been made so that they slide over the trunks so that when installed, there is room to fix them to the next section before sealing the edges.

End of a wind trunk, with a loose fixing frame

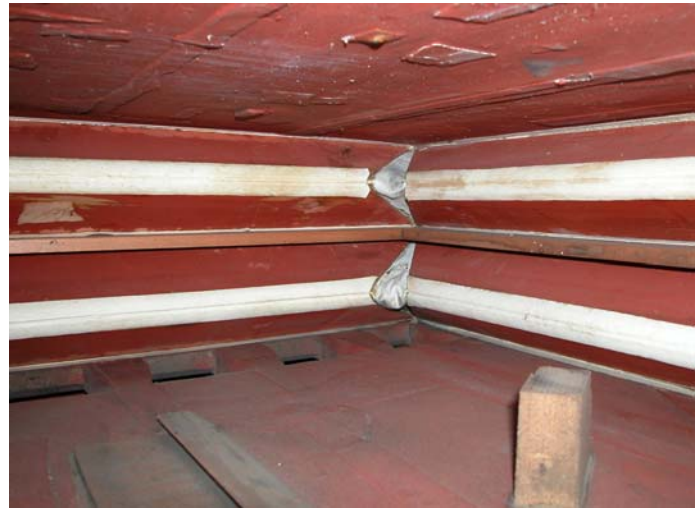
The bellows is a horizontal rise type, but with two sets of inward folding ribs, a rare survival of a transitional style, later ones having a set of inward and outward folding ribs. There is an outlet trunk on each side, with unusual vents from the bellows. The two feeders were taken off some time ago, but not thrown away. They were found and brought back to the workshop.

Interior of the bellows, before dismantling

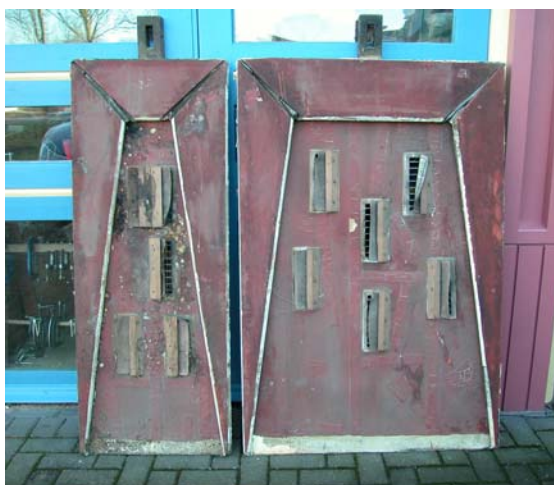
Inside of the feeders, before restoration

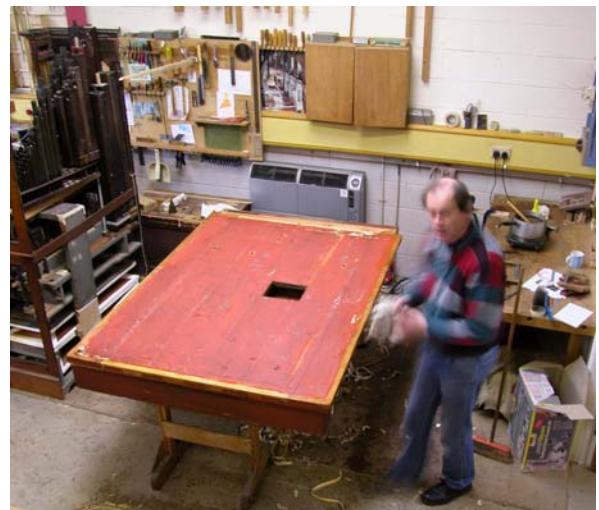
Dominic preparing the bellows

Having disassembled and cleaned the bellows, and repaired the few places that were broken, Dominic is preparing for the re-leathering.

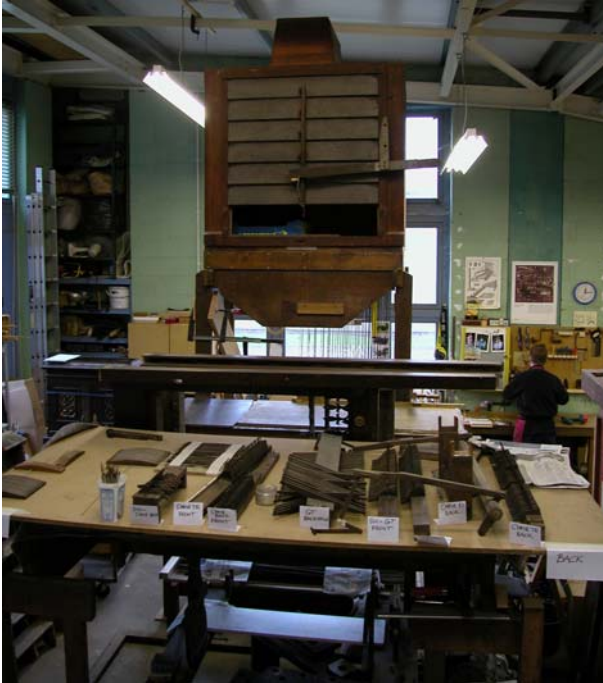
The compass of the Swell originally started at f. It was extended down to tenor c by sawing the soundboard in half and adding a new portion in the middle. The same was done with the Swell box, the central addition readily visible. A new front was then necessary, and this is what has survived. The six shutters are pivoted near to the top edge, and there are oak pins in the centre of the lower edge. Loose pins were repaired, the enlarged holes re-bored. Bedding around the edges was with two layers of sheepskin, which was renewed.

The Swell box in position. Action parts are laid out in front, with labels.

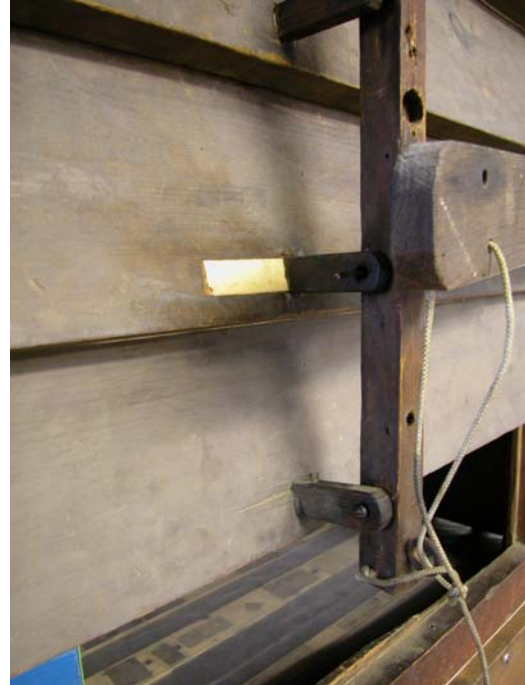
The Swell shutters and connecting mechanism.

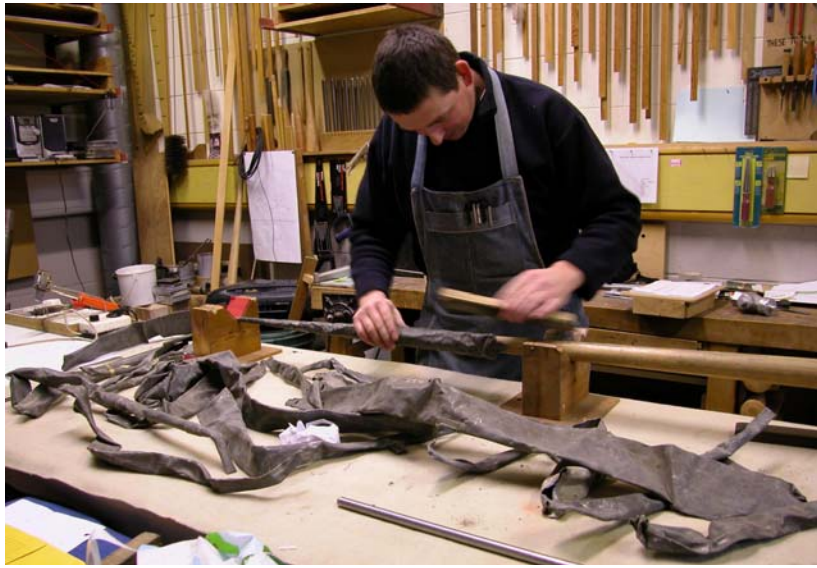
The exception is the reeds. A box in the organ and a pile of parts in the sexton's hut constitutes what is left of the old reed pipes. A start has been made on their restoration.

Stuart begins the pipe restoration
