St Margaret, Crick, Northamptonshire

1819 organ by Thomas Elliot 2008-9 restoration by Martin Goetze and Dominic Gwynn

Progress Report 3, May 2009

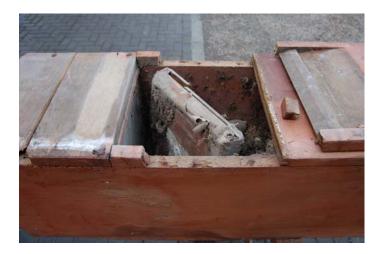
The largest pipe was also the in the poorest condition, as it had been lying on the ground in the sexton's hut in the churchyard. Apart from plenty of dirt, it suffered from woodworm damage, dry rot, failed glue joints, shrinkage, rusted screws, warped pipe walls etc.

After cleaning, it was necessary to produce an order of work so that one area of the pipe could be repaired before another, otherwise complete collapse would have resulted. While the insides were at their most accessible, paper and paint that had been used during manufacture were either carefully removed or stabilised with glue size.

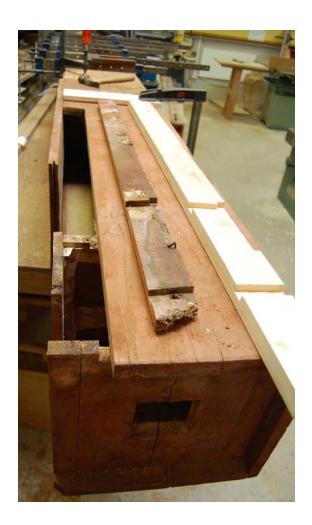
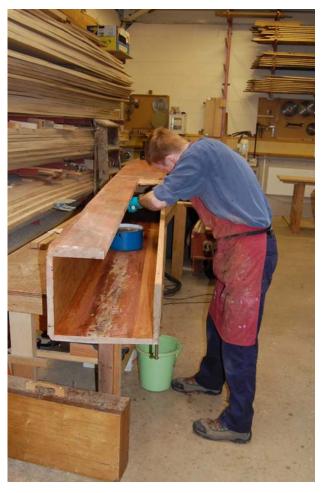
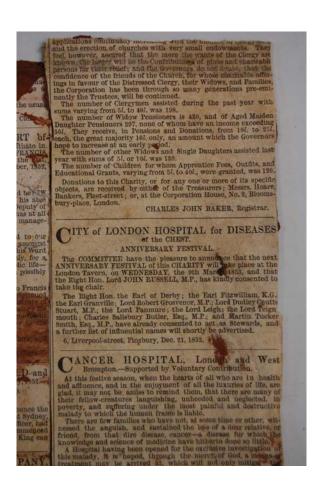
Dates on some of the lining paper confirmed that the pipes and the Pedal soundboard were probably made at the same time. The inside corners were sealed with folded lengths of brown packing paper. After the walls were rebuilt, the four inside wall surfaces were lined with more paper. This was applied by rolling each of the four pieces up (having been cut to size), rolling thinned glue down the length of the pipe, and unrolling the paper followed by more size.

Paper used for lining the GG pipe, with a date of 1852
