St Margaret, Crick, Northamptonshire

1819 organ by Thomas Elliot
2008-9 restoration by Martin Goetze and Dominic Gwynn

Progress Report 2, January 2009

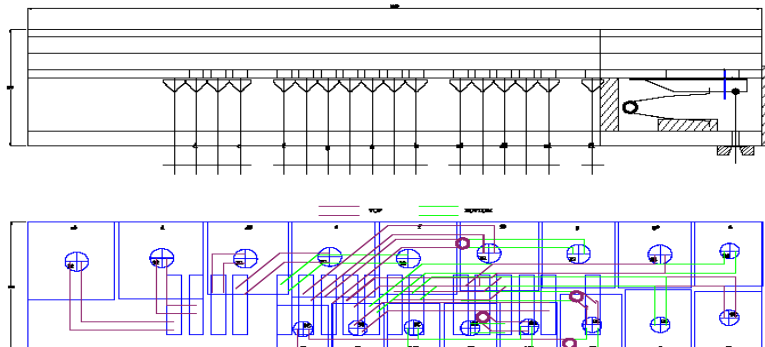
ST MARGARET, CRICK, NORTHAMPTONSHIRE Pedal soundboard, 1853 - top		
Drawn: M. H. G.	19th January 2009	Full size
Martin Goetze and Dominic Gwynn 1-2 East Workshops, Welbeck, Nottinghamshire S80 3LW

The pedal department is in two parts: a seventeen note soundboard with pipes, and an additional, modern, soundboard with more recent pipes. It had been assumed that the seventeen note part dated from the arrival of the organ at Crick, or even possibly earlier. The pencilled inscription inside reveals that it is from 1853, made under the supervision of H. T. Elliston of Leamington.

The additional soundboard was made in 1978 by Robert Shaftoe, though the pipes appear to be late nineteenth century, from an unknown source. It was decided that these pipes should be retained, but three new ones at the top added in order to complete the pedal compass to f. The 1978 soundboard is made from chipboard, and although is good condition, did not allow for the additional pipes. A new soundboard has been planned, and it will be made following the details of the 1853 soundboard.

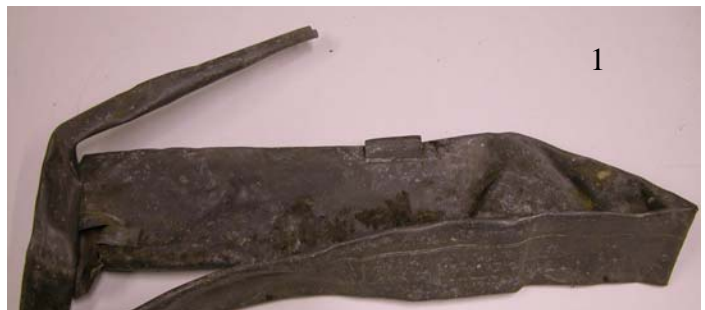
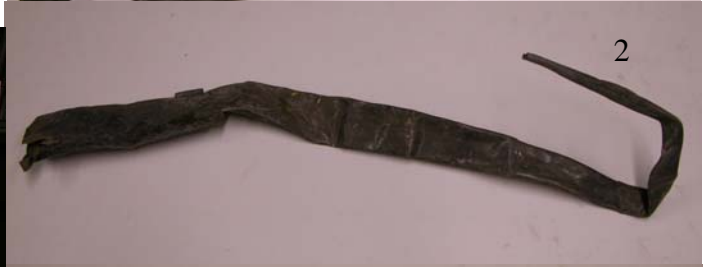
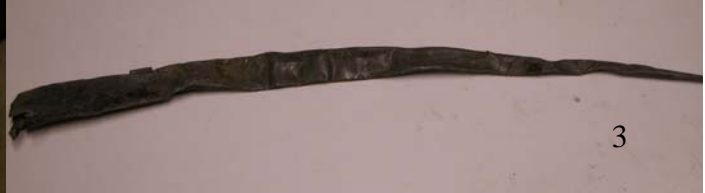
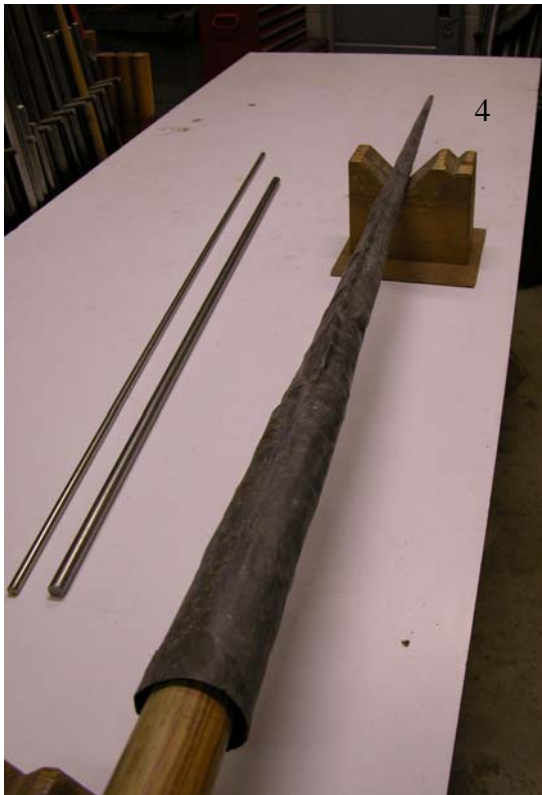
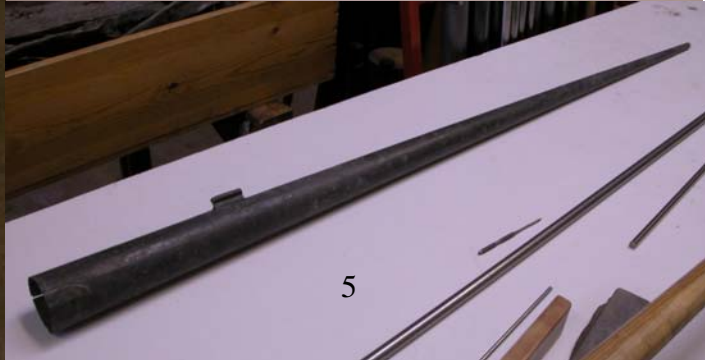
Five stages of a pipe restoration

The metal pipes have been examined, cleaned and identified. An inventory has been made which shows the position of each pipe as it was before the present restoration. Where pipes had been transferred, they have been returned to their correct places. The Mixture pipes had been moved more than other ranks, and required a closer examination of the original markings before their correct places could be identified. The pipework is generally in good condition, so it has not been found necessary to make many repairs, though there will be extensions to make.

The exception is the reeds. A box in the organ and a pile of parts in the sexton's hut constitutes what is left of the old reed pipes. A start has been made on their restoration.
